## **The Danby Group's DG-110 VIN Labeling System Increases Efficiency and Cuts Waste for Major Auto Manufacturer**

## CASE STUDY

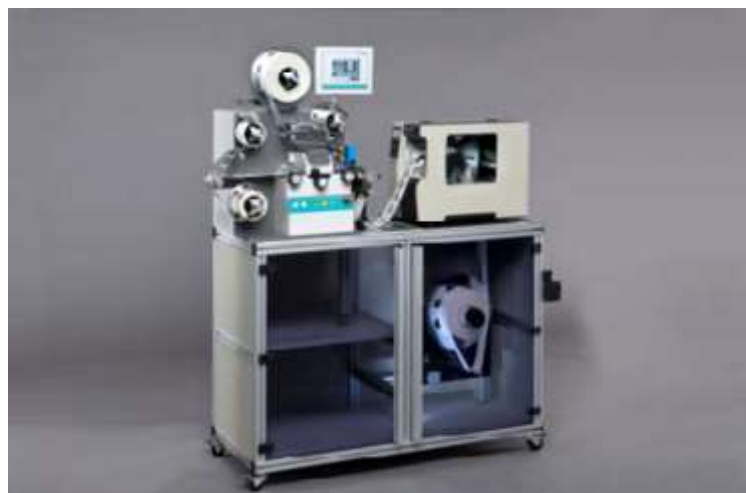
A Microscan scanner reads each label and ensures bar code readability. If a label has a bar code that does not properly correspond to the data from the database, a hole is punched in the label indicating it has failed verification/data validation testing and renders the label unusable. If a poor quality bar code is printed, the printer repeats the printing process with a replacement label that is not punched. After this step, a clear over-laminate automatically covers the label before the labels are individually die-cut. The waste matrix left around the die-cut label can be stripped away from the label allowing the die-cut labels to be rolled or used immediately. To avoid production errors such as having the labels used out of order, they are removed from the label liner in the sequential order that they are printed.

The DG-110 printer/laminator prints the information content for each certification label using Zebra's 110Xi4Plus printer. Thermal transfer printing is the preferred printing technology for this label because, in addition to printing the label in real- time, thermal transfer printing produces VIN number bar codes that are the most easily read of any other print-on-demand technology. An added benefit of this print technology is the clarity of any graphics, logos, or the text printed in various fonts and point sizes.
